# Camborne Mews, Wandsworth

## *Ground Investigation Report*

CAMBORNE MEWS

Report Ref: R0671/21

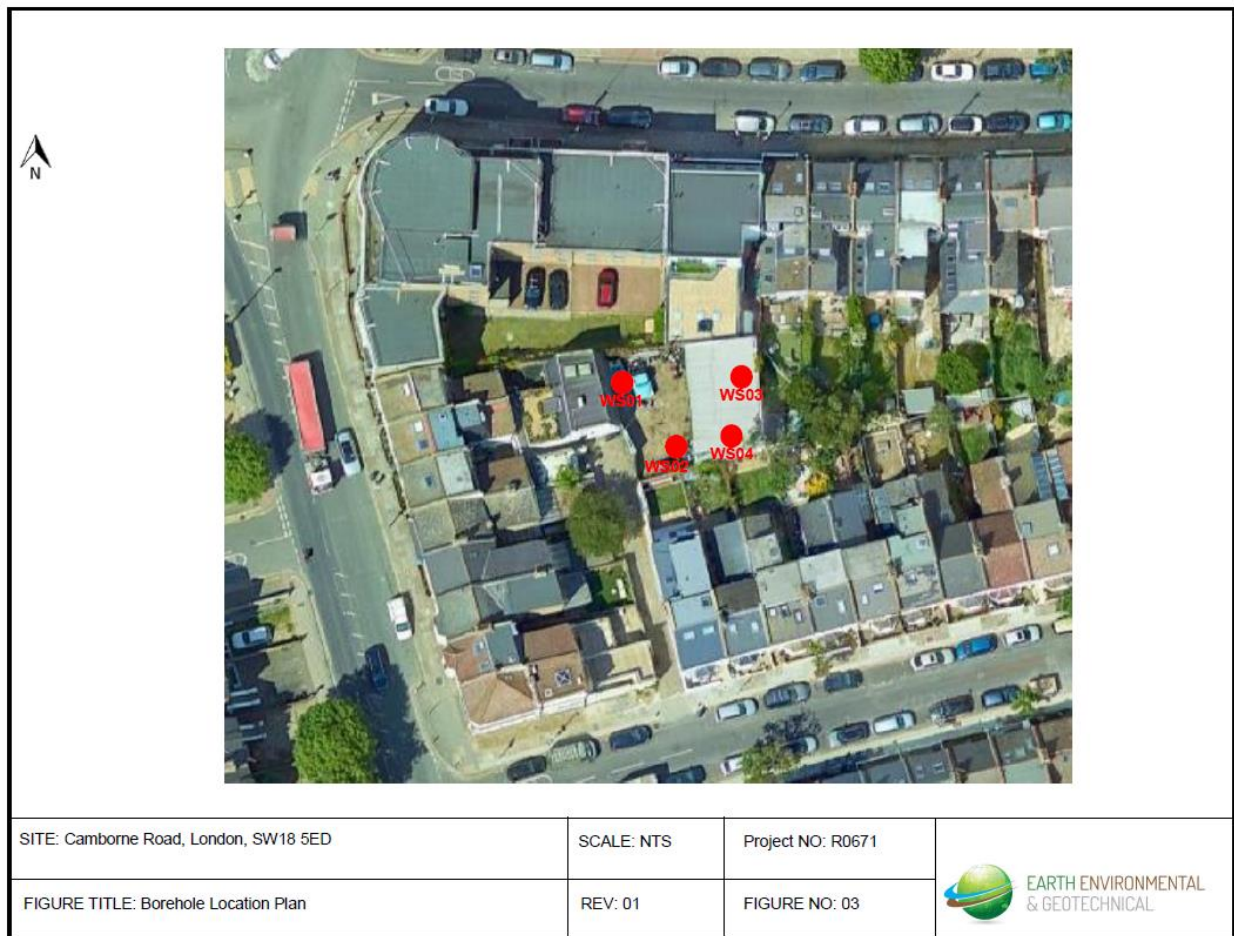
**Figure 3: Exploratory Hole Location Plan**

The fieldwork was carried out generally in accordance with BS 5930:2015+A1:2020 Code of Practice for Site Investigations unless otherwise stated. The exploratory hole locations were determined on site by EEGSL and considered site restrictions present at the time. The investigation locations completed are shown approximately on the Exploratory Hole Location Plan overleaf (Figure 3).
